Final Conservation Report for the Memorial to

Henry Vaughan

The Church of St Ffraid - Llansantffraed - Brecon

FINAL CONSERVATION REPORT FOR THE MONUMENT TO HENRY VAUGHAN † 1695

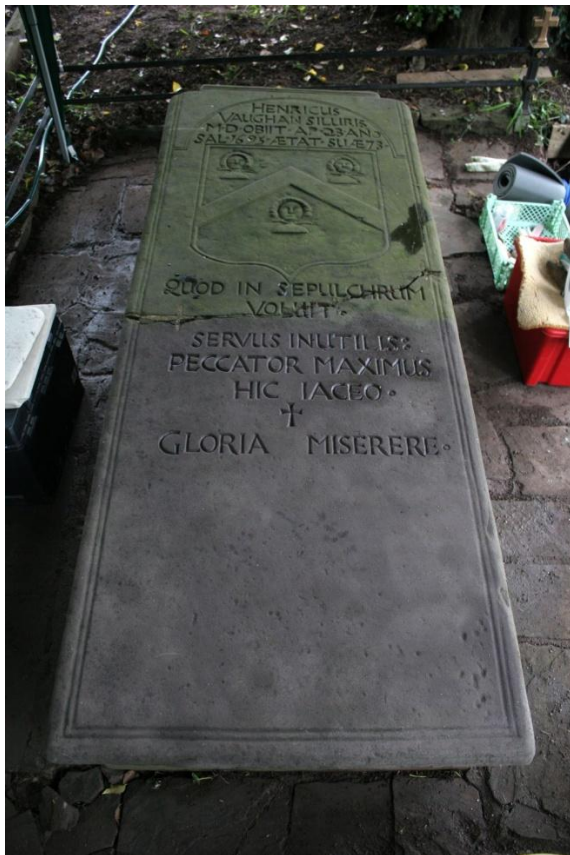
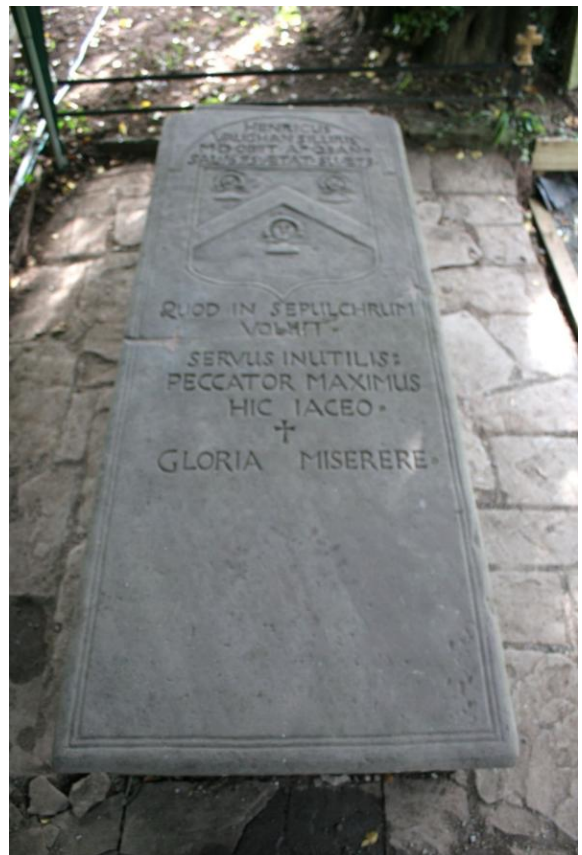
General views of the top incised inscription slab during cleaning on the left and with all treatments completed on the right. Note the laminar structure of the stone slab is much more pronounced after cleaning, with light and dark banding. Note how uniformly colonized the un-cleaned upper section is, this will happen again relatively quickly, causing the new alkaline surface of the hydraulic lime filling medium to blend in with adjacent sandstone surfaces.

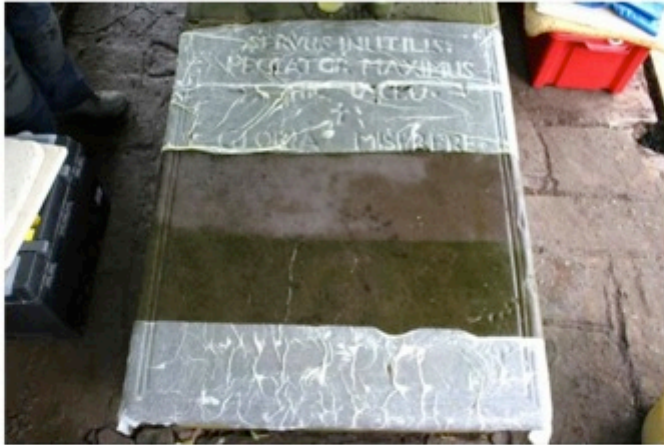
Cleaning in progress to the lower section of the slab. The surfactant (which has a mild biocide effect) is painted onto paper toweling to keep the active ingredient in direct contact with the biological growth. Paper is then peeled back and algae removed with stiff bristle brushes and constantly changed clean water with dirt/debris absorbed onto dry paper toweling.

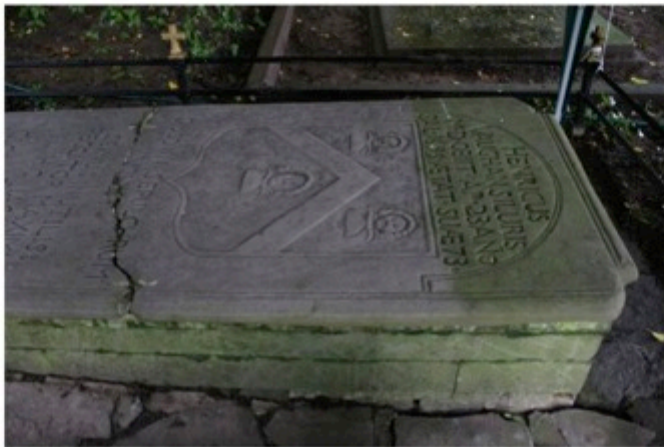
The upper inscription still to be cleaned, highlighting the contrast between treated and untreated surfaces.

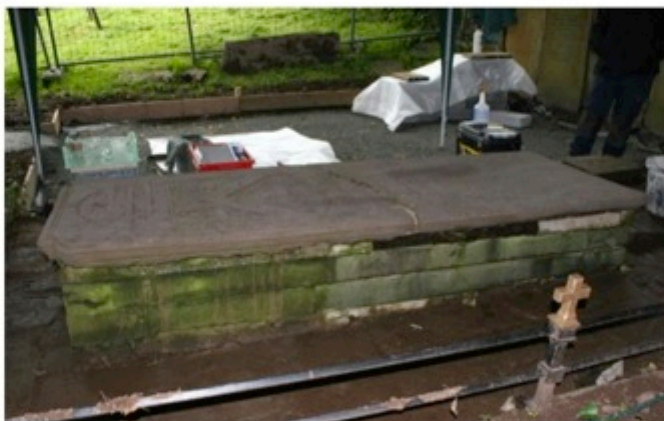
The upper slab has been cleaned, with the south elevation of the plinth showing cleaning in progress, using the same technique and materials as the carved surfaces. Note the thickness of the massive joint at the right-hand corner.

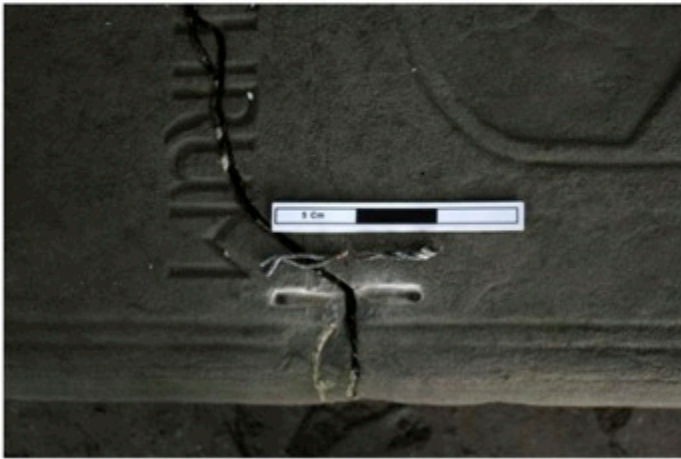
4.1 The two twisted copper-alloy wire fixings that had been used to join the fracture were removed carefully with the aid of small chisels and a 'Dremel' micro-drill using a carborundum disc. These fixings and the joint had been filled with a very fine pourable (now brittle) material that had the appearance and characteristics of 'Ciment Fondue' a casting material developed in the 1970's. The sides of these channels were rounded and would not have held onto the subsequent filling medium properly in the long-term. As a result the channels were dove-tailed with the aid of the 'Dremel' using a diamond disc and shaped carborundum heads to create an inverted 'V' shape.

The insubstantial, twisted copper-alloy fixing removed from the viewer's right-hand side of the slab. The bottom of the channels were rounded and no good for holding onto newly placed repair mortar.

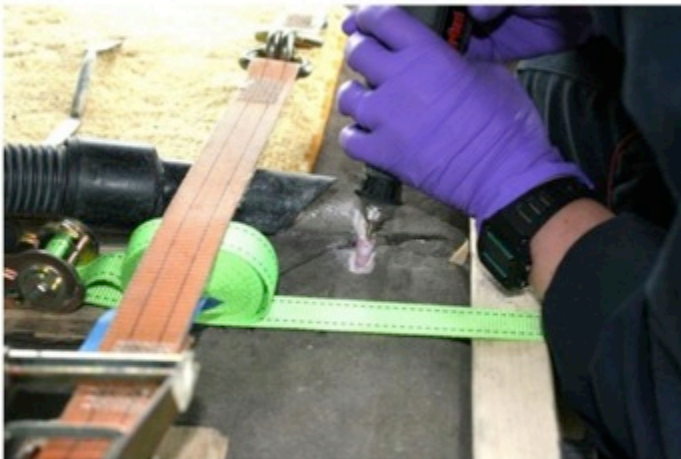
One of the channels being 'dovetailed' to provide a better key for the repair mortars. Note the ratchet straps were applied around the slab in both axis's during curing of the epoxy resin used to prevent any unwanted movement.

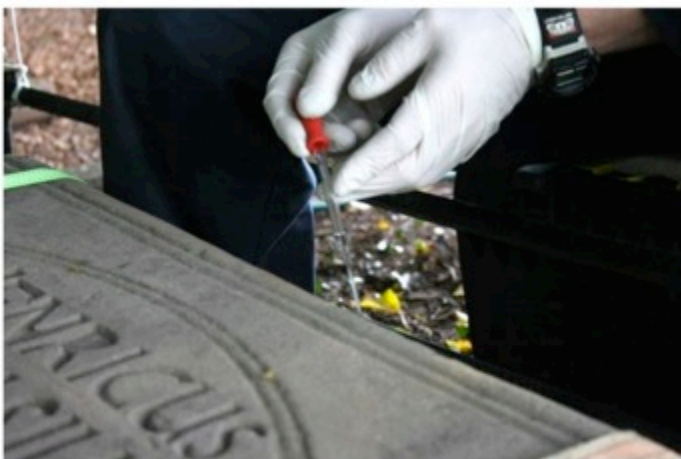
Consolidation of the laminating surfaces in progress. The water-clear acrylic resin was applied by pipette with the capillarity of the laminations drawing the consolidant into the fissures, effectively bonding both surfaces together after polymerization of the resin.

4.9 The springing laminations were consolidated by introducing a weak acrylic resin solution (5% Paraloid B72 in Acetone : I.M.S, 50 : 50) by pipette. Three cycles were injected in total and were successful in re-bonding the de-laminating layers, such that they were solid. The consolidant will slow down, not prevent, water entering these areas. Work was also done to several of the letters in the upper inscription which displayed laminations and the potential for springing and eventual loss.

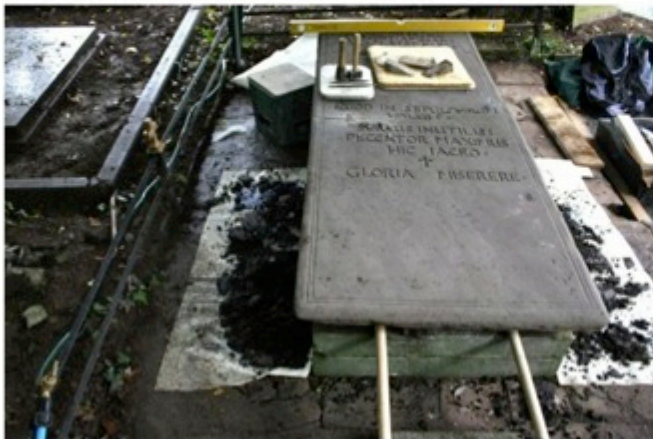
The slab having been cleaned, prior to removal of the lower section. Note the dark material either side of the slab is some of the soil which it was bedded on

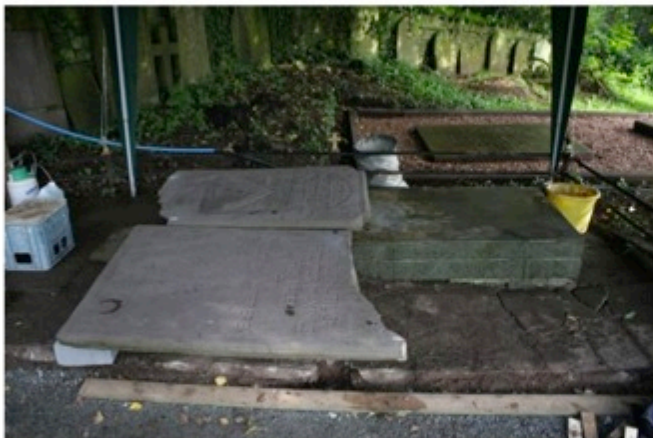
Both sections having been removed to reveal the sound surface of the slab immediately beneath, which was heavily tooled with no obvious signs of fractures, laminations or geological faults. Note the top bed of the lower slab has been removed of all soil and water washed to provide a clean, flat surface for re-bedding the re-joined slab.

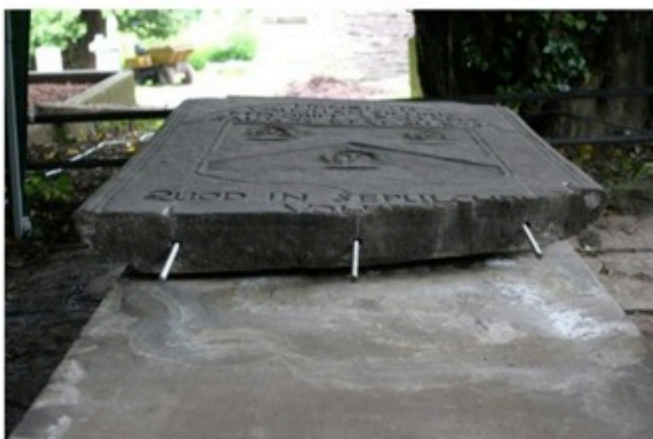
The three 10mm diameter, threaded stainless-steel dowels (each 150mm long) prior to marrying up with the lower section and securing with epoxy resin. Note the uneven nature in the thickness of the slab from side to side. Note also the sound condition of the underlying slab, which is wider and longer than the historic carved slab above.

4.4 Three 10mm diameter, stainless-steel (316 marine-grade) threaded dowels each 150mm long were set into corresponding dowel holes in both sides of the break. The dowels were secured into position with an external grade epoxy-resin, which was also applied to the break edges to make for a strong bond. The slab had three ratchet straps applied to help achieve the correct alignment and prevent any movement whilst the conservation grade resin was polymerising. These were released after 24 hours, when the retained resin samples had reached full strength.

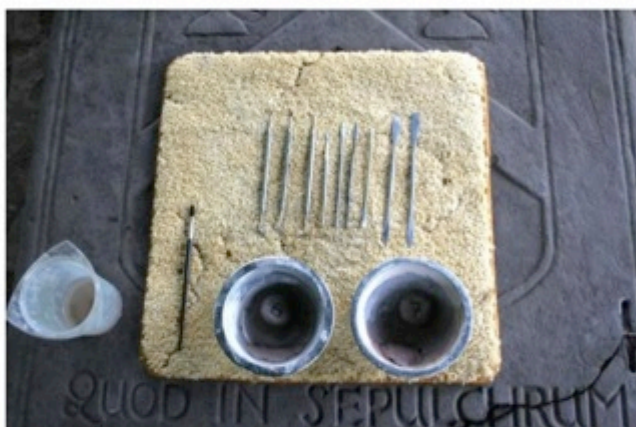
Two repair mortars based on a hydraulic lime binder using the same stone dust as the host stone were selected to be similar in terms of texture and colour, but weaker than the historic stone, which was vivid in colour once cleaned. The disparity in colour between the filling medium and the cleaned surfaces will diminish once the slab begins to be colonized by biological growths. Note dental tools and small spatulas were used to pack the mortar deep into the vertical fissure, which was much smaller this time due to the quality of the join.

4.8 The two different repair mediums were based on 1 part NHL 3.5 with 2.5 parts crushed purple sandstone dust (of two different particle sizes) and slate dust to darken the purple coloured dust as far as possible.

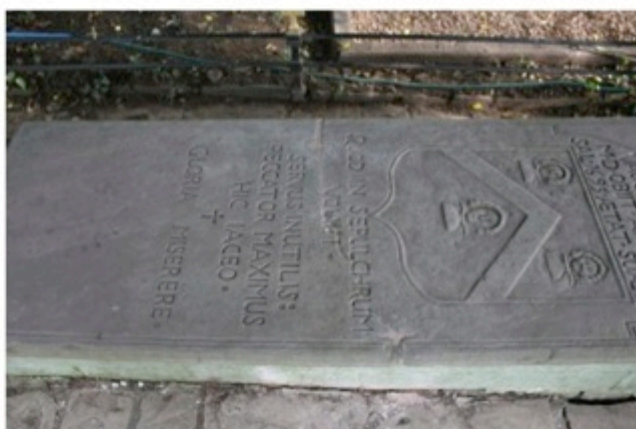
The join after filling was complete. Mortar was inserted to prevent water pooling in the lettering. The filling medium comprises of crushed/sieved purple sandstone dust, red sand and hydraulic lime NHL 3.5.

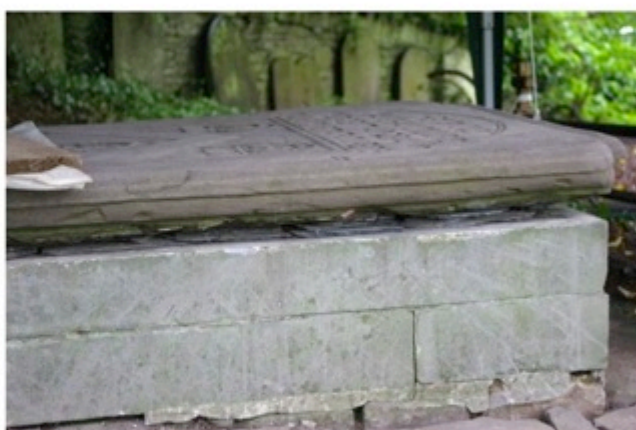
3.4 After cleaning it became clear splashes from a previously used biocide had splashed over the plinth leaving isolated areas much cleaner than we could achieve even using phosphor-bronze brushes and water. This was halted swiftly as the soft metal brushes disrupted the sandstone surfaces unacceptably. The biocide had killed and slowed down biological growths, with the remaining green areas showing biological growths on a microscopic level, below the

The join between the upper slab and the plinth. The slab was leveled on strips of lead to provide solid, uniform support and then slate fragments packed in around the whole perimeter to provide additional support and something solid against which to apply the pointing mortar. Note the splash marks on the upstand of the plinth caused by uneven application of a previous biocide.

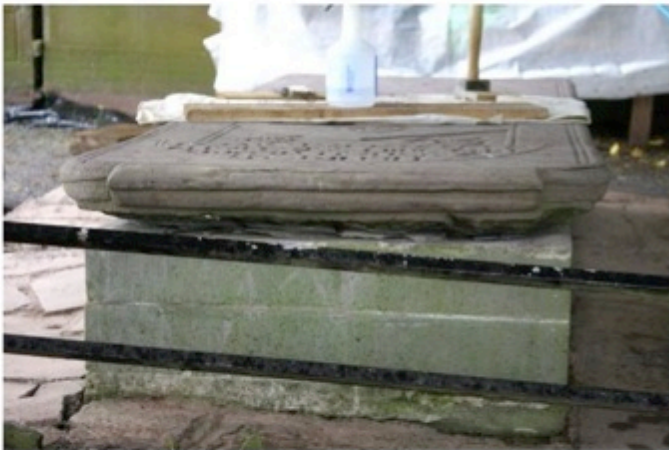
More slate fragments in the west elevation joint, note although the historic slab and plinth are parallel and largely level, the angle of the railings gives the impression of a lean, which is misleading.

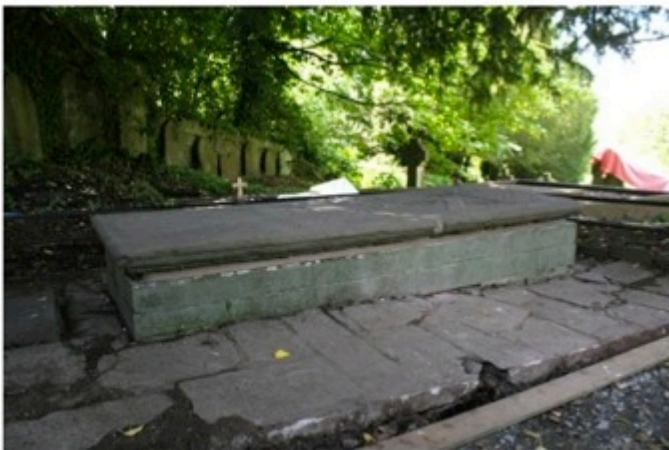
The completed works from the north elevation, note the joint between the slab and plinth has been recessed so as not to create ugly, wide joints and to reveal as much of the moulded edges as possible. The mortar is designed to be weaker than the historic stonework.

4.10 The memorial slab is smaller in terms of its footprint than the plinth beneath, and present problems with regard to filling. The joint was pointed to leave as much of the original stone slab moulding exposed as possible, in accordance with current best practice. Over filling joints accelerates deterioration with water collecting behind 'feathered edges' as was witnessed in the mortar removed, despite being too hard for the host stones.

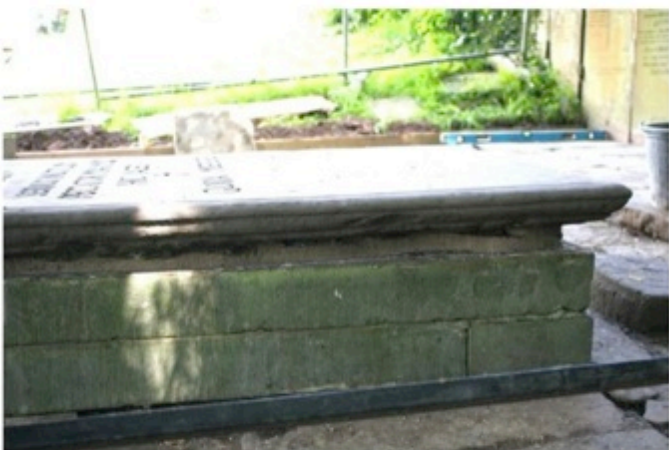
4.6 Upon movement of the slab, it became clear much of the bottom bed has delaminated historically, making it very uneven with now very different bed heights in each of the four corners ranging from 74mm (south-east) to 92mm (south-west). The top bed of the slab is not flat from side to side with the south-west corner kicking up. With a string run along the top bed from side to side along its longest side there is gap of 7mm and 11mm on the south and north sides respectively. Joining the slab with the string flat along the slab would have produced a massive gap between the letters bisected by the fracture and would have had little or no contact along the break edges. These discrepancies made bedding the slab difficult as the plinth is largely level along its long and short axis's. A compromise was arrived at which meant there is still a small degree of lean down to the north elevation (8mm out of true level) but means water will not sit in the incised lettering or winged angels.

The joint to the south-east corner, note the uneven thickness of the joint is directly related to the historic loss of material from the bottom bed of the slab which has delaminated significantly over time.
